Photographic Summary

Luke Air Force Base Five Year Review Photographs 7 and 8

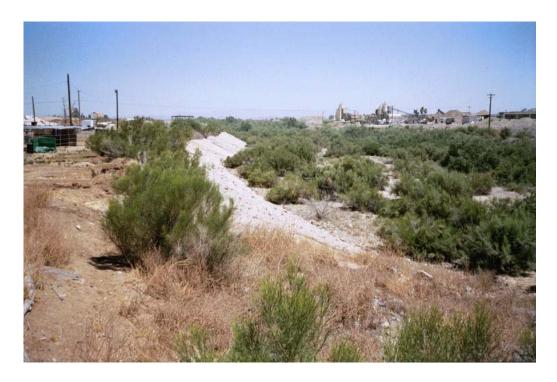
View of Bank Stabilization at RW-02

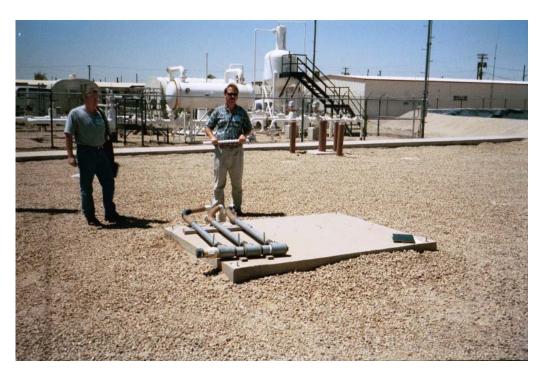
SS-42 pad where SVE pad was
